## **Assessment of Dam Safety of Coal Combustion Surface Impoundments**

**Indianapolis Power & Light Company**

**Harding Street Generating Station**

**June 4, 2010**

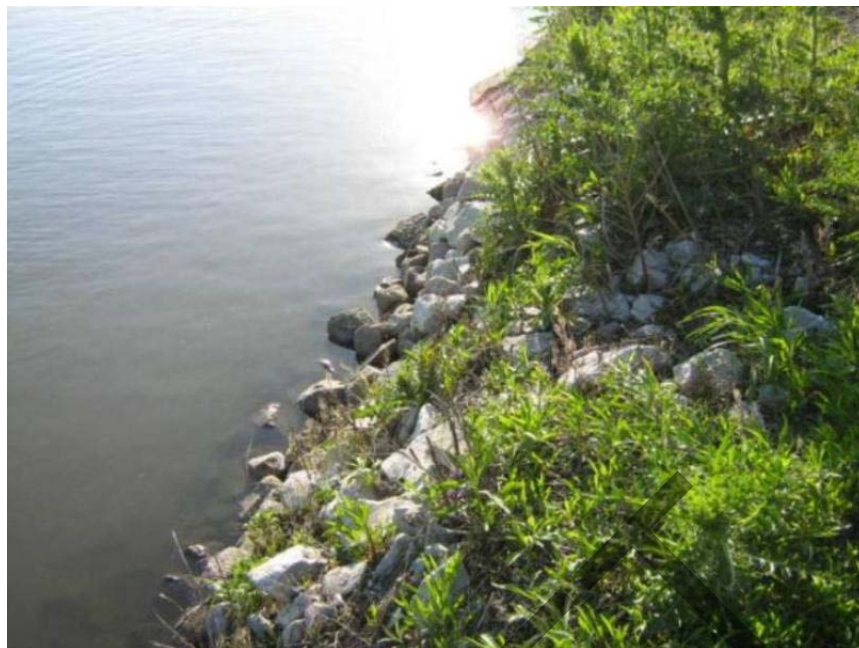
166. Ash Pond 4B - Riprap on South Embankment Interior Slope, Looking East

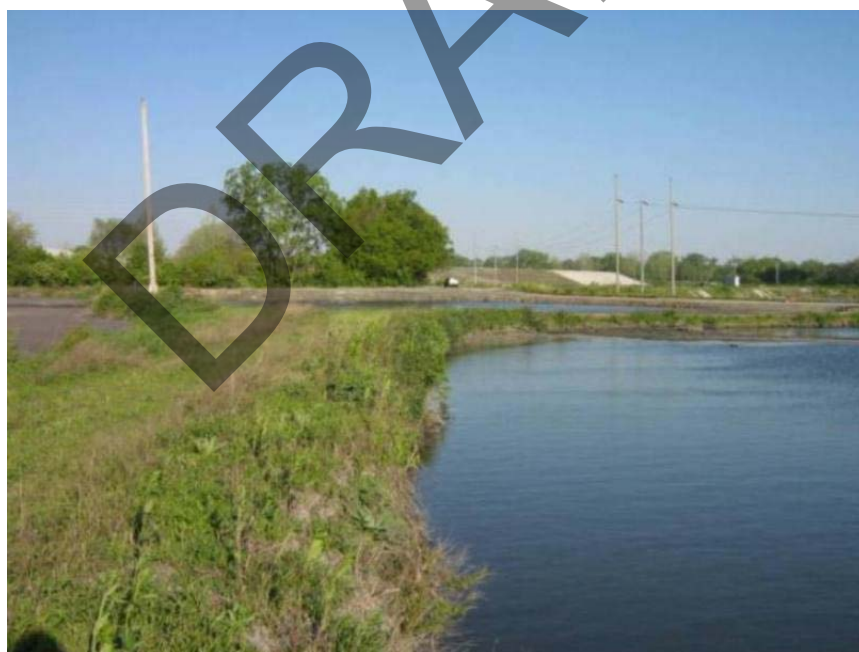
167. Ash Pond 4B - South Embankment Interior Slope, Looking West

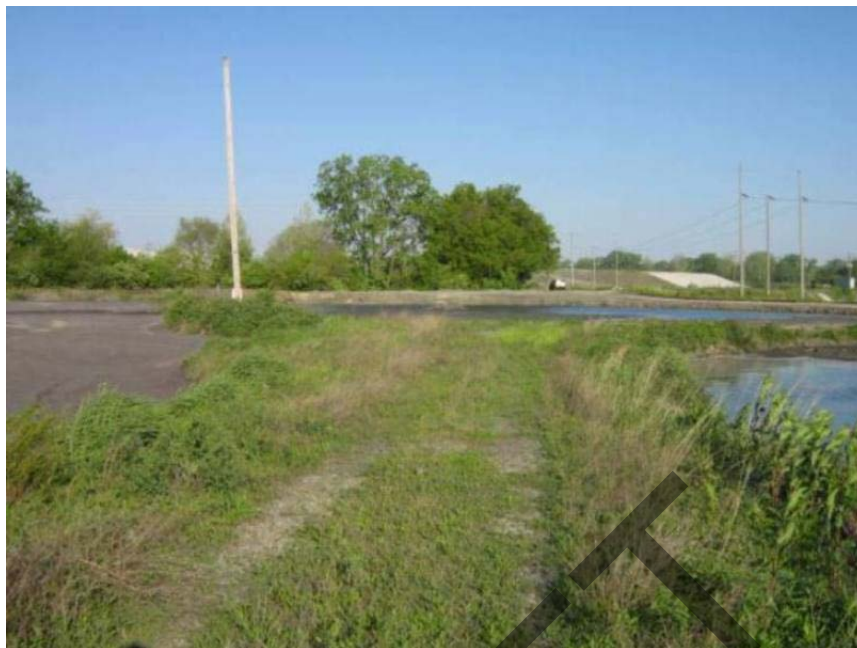
168. Ash Pond 4B - South Embankment Crest, Looking West

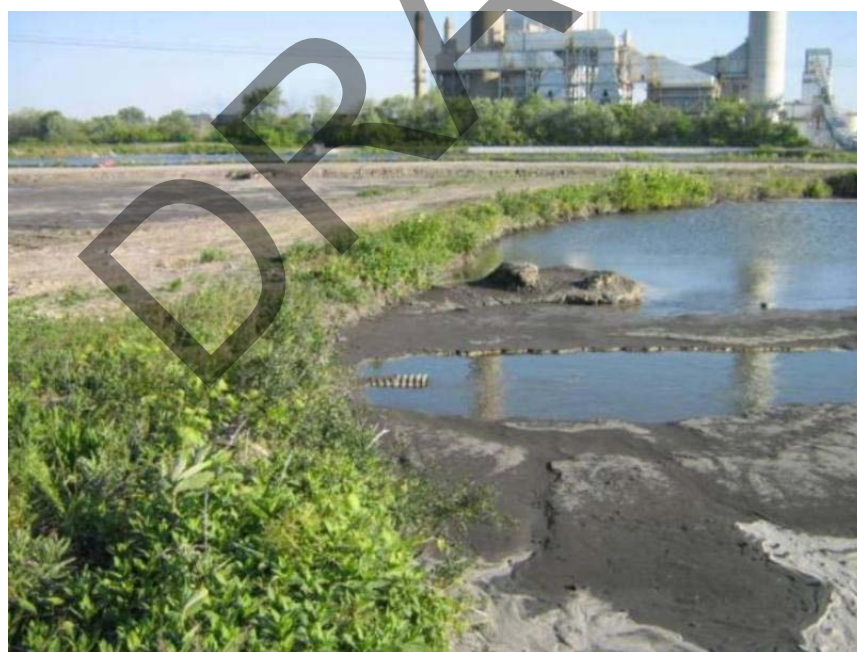
169. Ash Pond 4B - Inlet/Outlet to Ash Pond 4A located along West Embankment Interior Slope

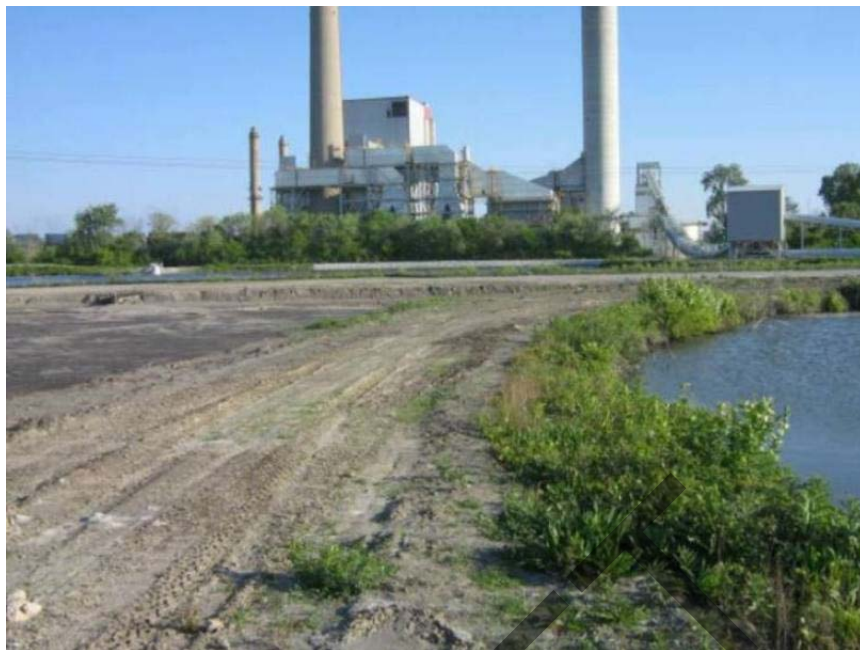
170. Ash Pond 4B - West Embankment Crest, Looking North, Ruts from Vehicle Traffic Visible
